## Possible Frame Issue

Some owners on the French ER-6N/F (Ninja 650R) Forum, Kawette.net and the Italian er6italia.com Forum are reporting cracks to the frame in the area of the R/H forward engine mount. Following are pictures of damage to this area.

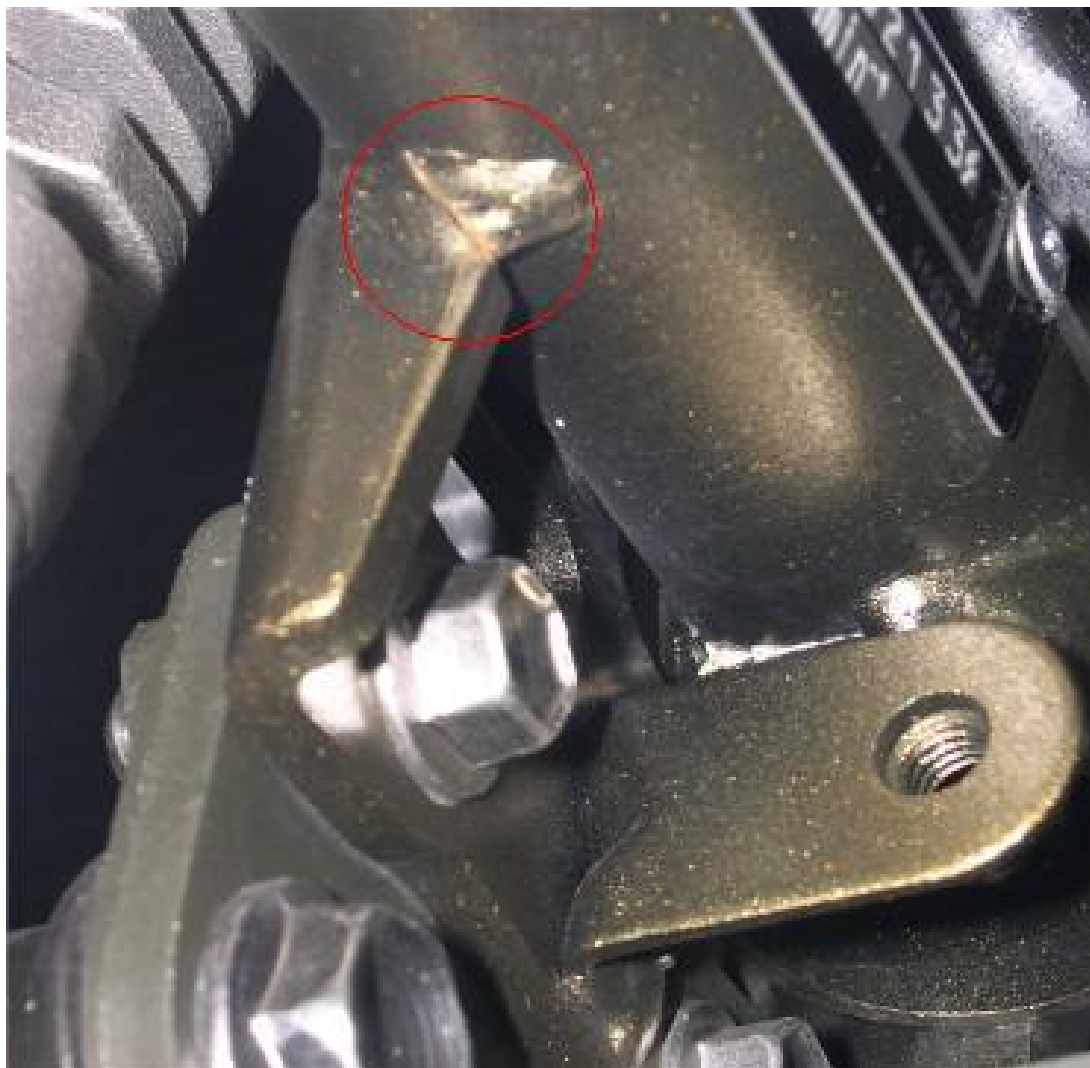
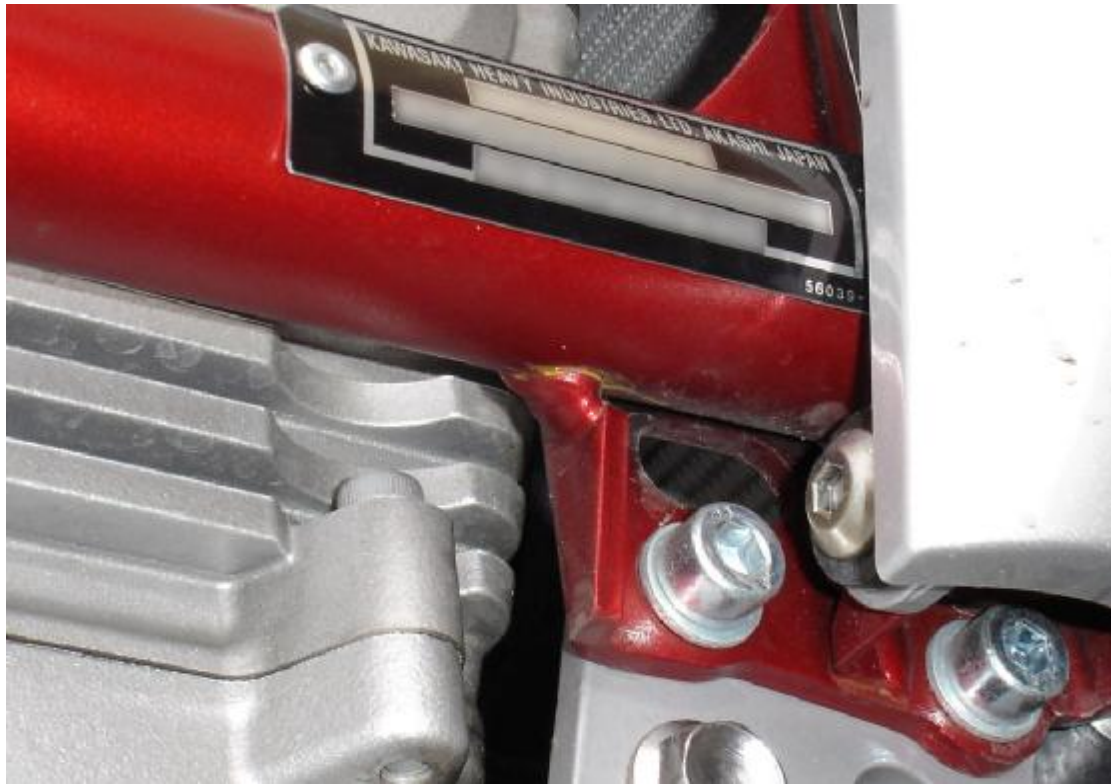
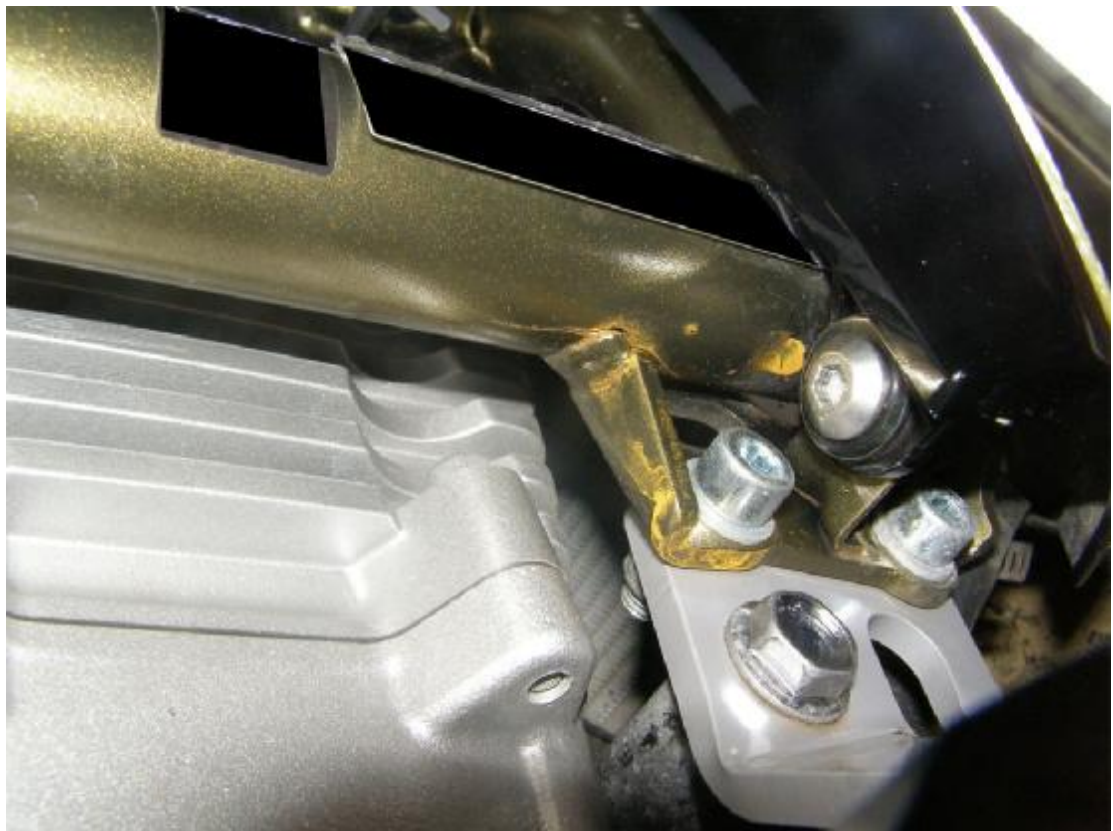
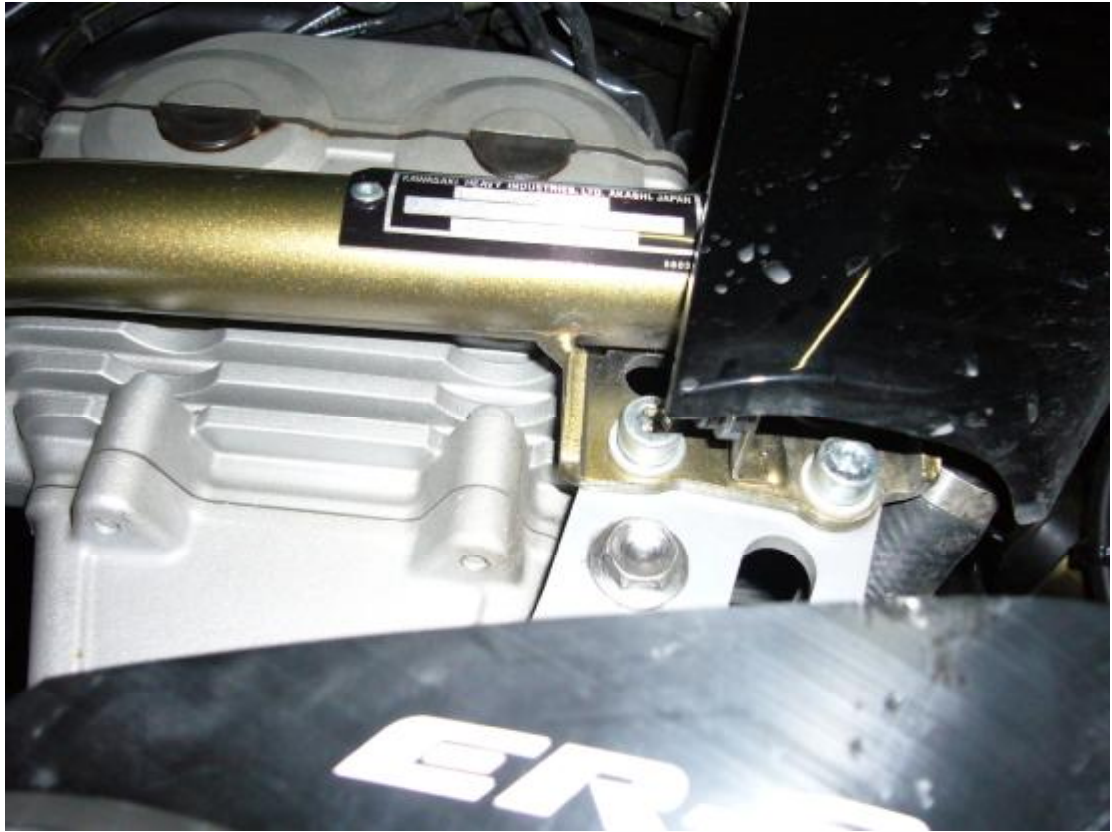
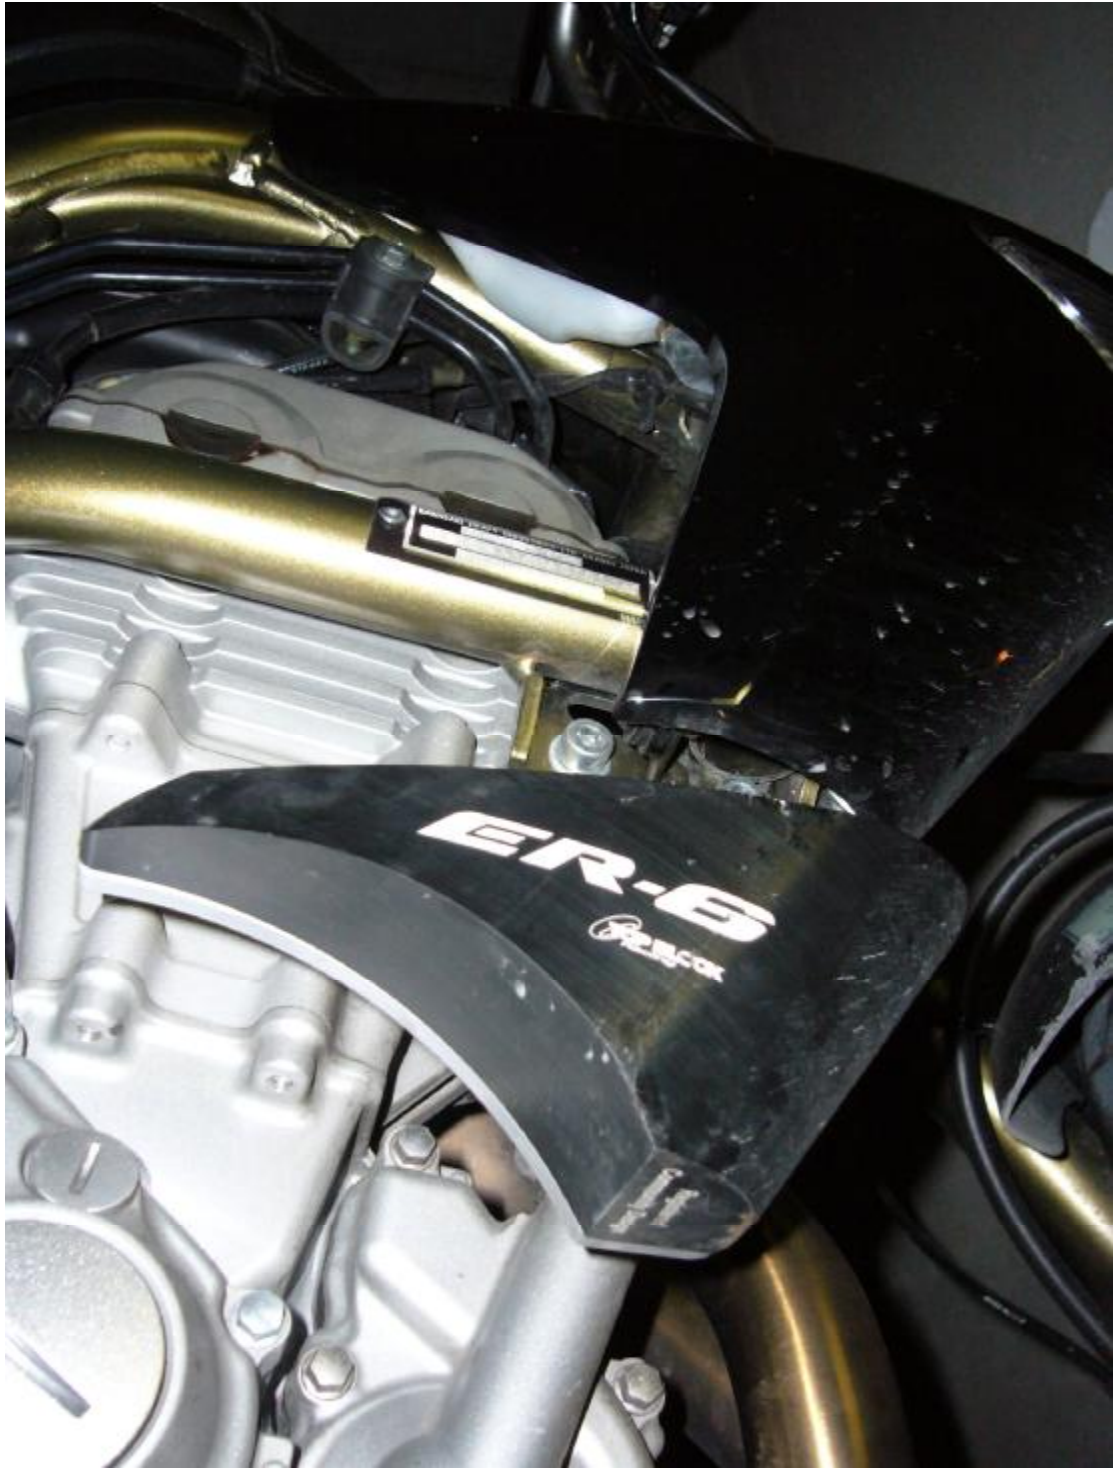
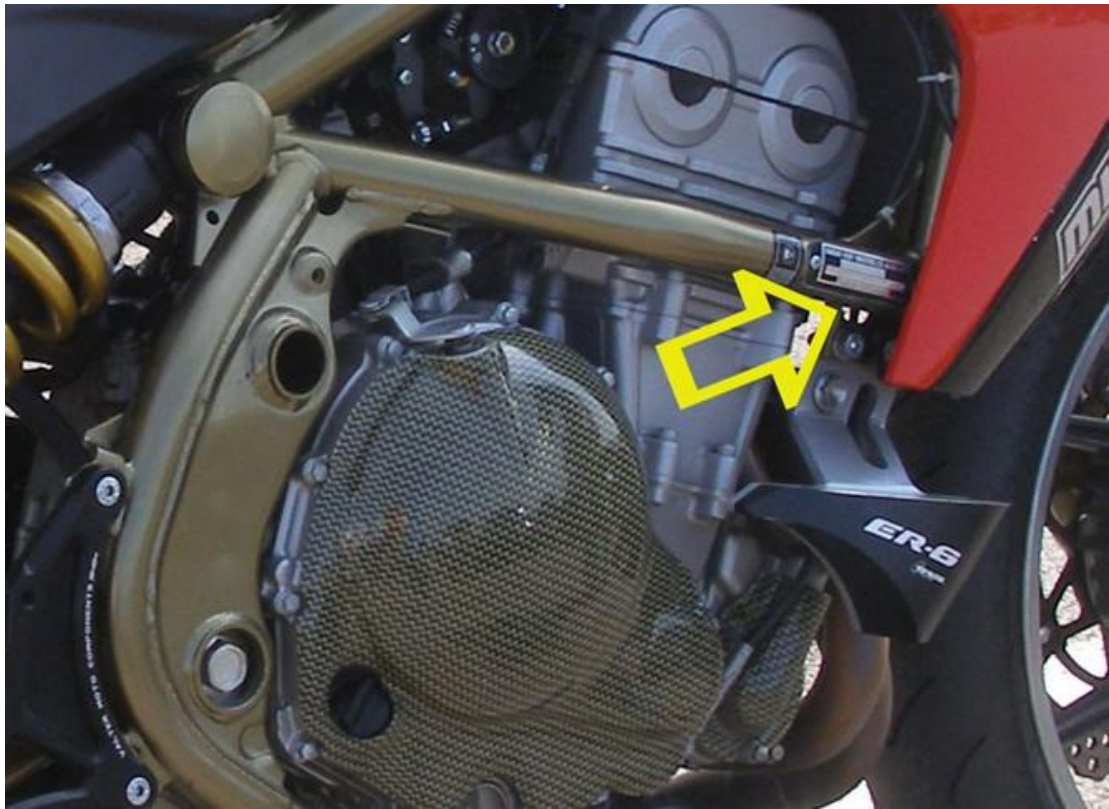
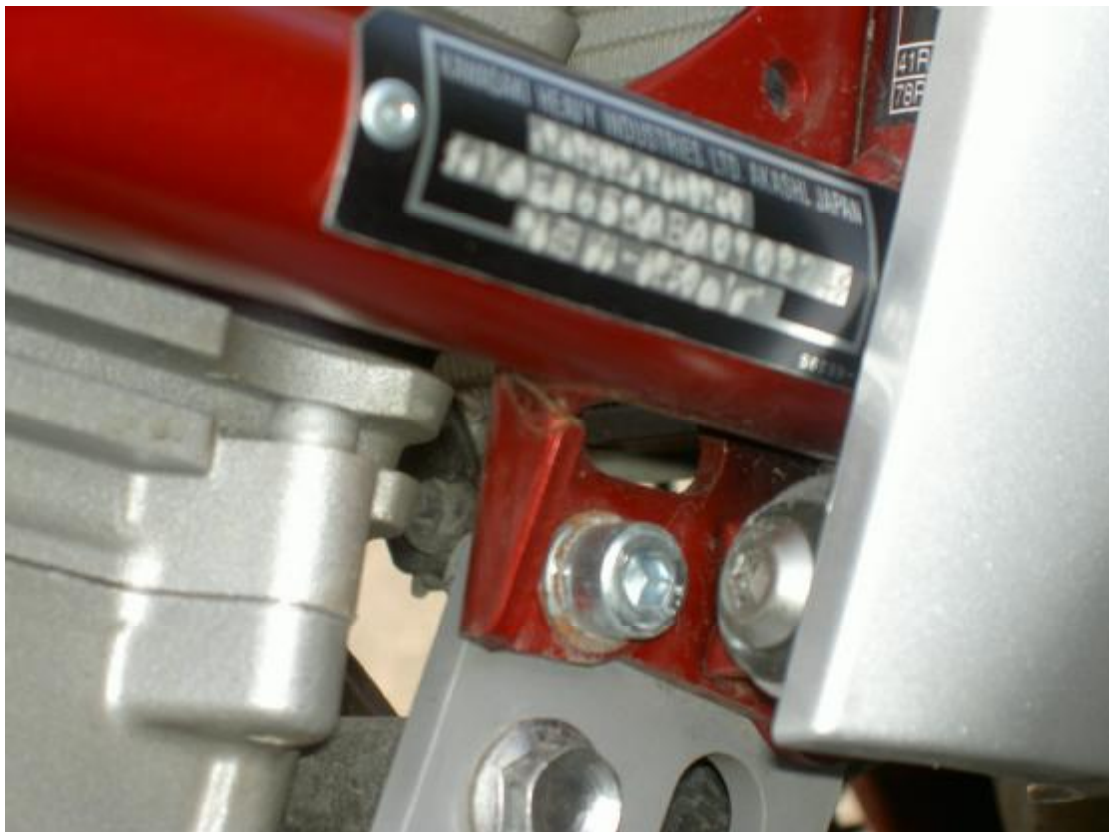
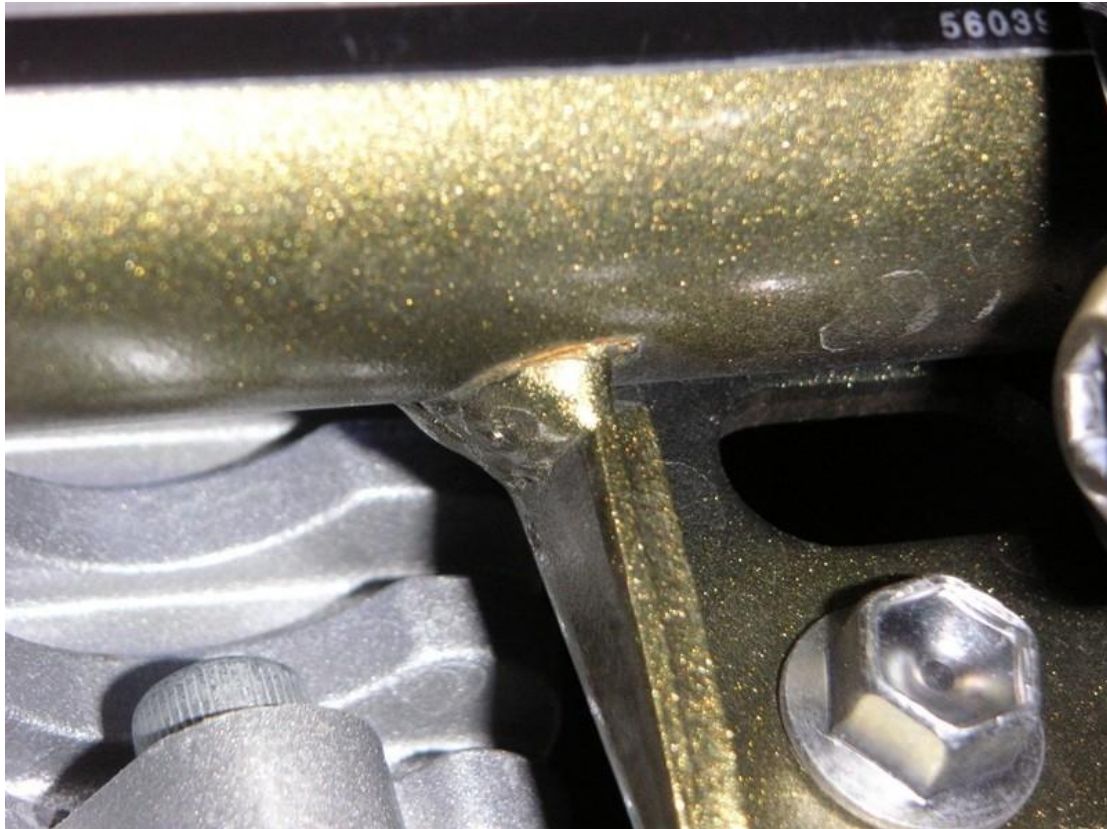
From reports on the USA and French Forums the cause of the fault appears to be that the distance between the upper motor mounts is too far apart during manufacture and when the motor is fitted and the mount bolts tightened excessive side loads is causing the right hand forward frame mount weld to crack.

Owners are urged to inspect your frame now! With the ER-6F (Ninja 650R) use a mirror and a torch and view the suspect weld through the R/H cowling vent. If you find a crack contact Kawasaki or a Kawasaki Dealer.

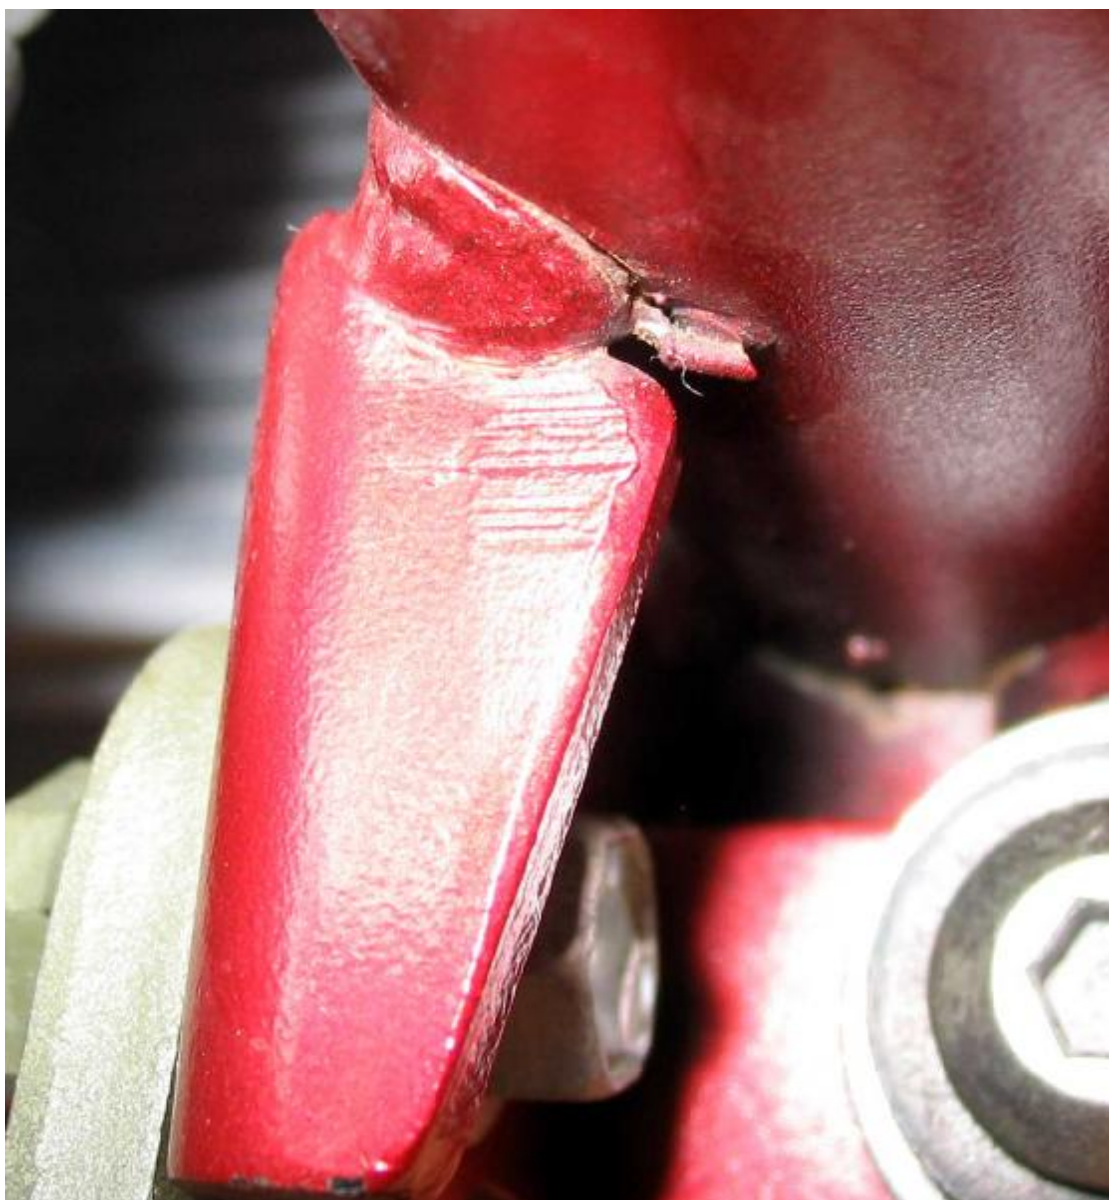
Thanks for the info Kiwi\_ER-6F. I've just discovered the engine mount bolt is broken on that side on my bike. But the frame seems ok.

edit: had a better look, and oh no!

They have come to the same conclusion as most of you...the engine mount on that side is horribly over-torqued, to compensate for the cylindrical spacer around the bolt being too short. End result is the frame is bowed inwards by 3-4mm. This is leading to the problems of snapping engine mounts and cracking welds.

Finally got time off work to take the bike in to the dealer. They were very good. Inspected the weld and decided nothing had cracked \*yet\*, which I do agree with. Took down the VIN number and my details, in case something does happen and it gets worse. They replaced the broken engine mount immediately.

The mechanic tested all 3 ER6's in the shop, and all of them had the same problem. At standard torque settings for the engine mount, there was 3-4mm (and in one case 7mm) free play in the spacer. All were over-tightened to close this gap. He installed a washer as a spacer, until something more permanent can be done.

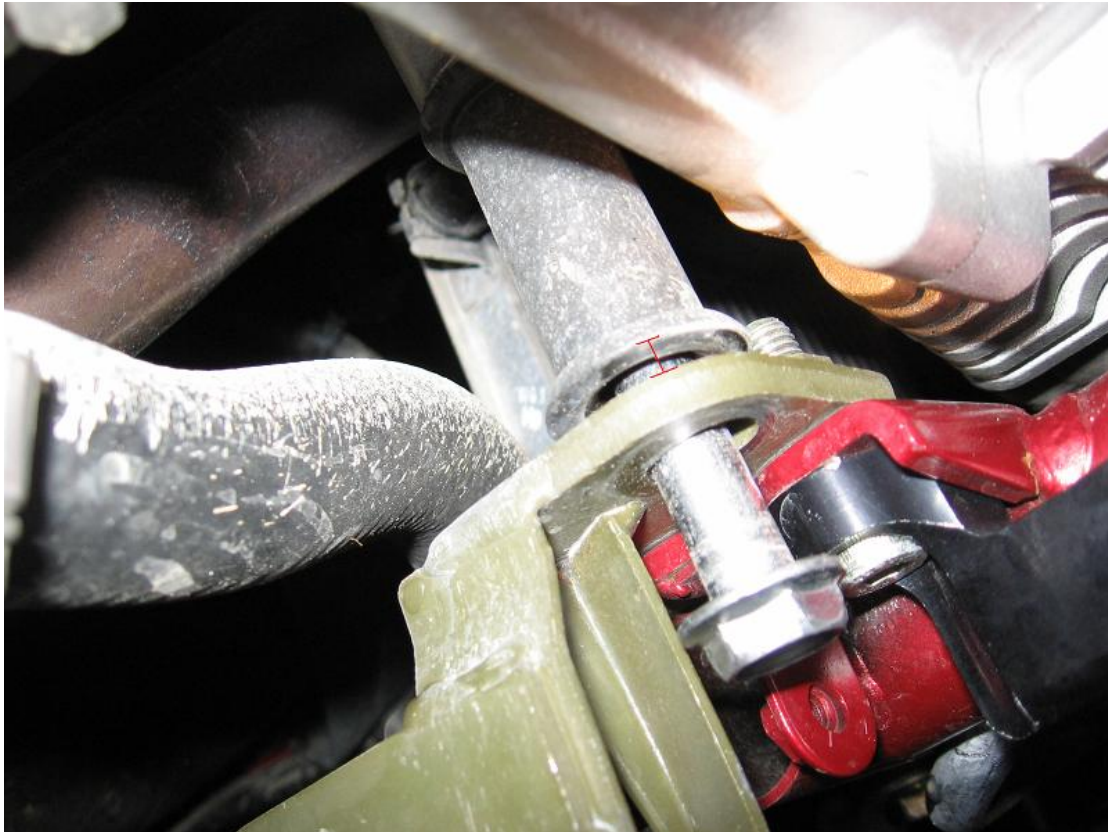
Just about a 5mm gap on the right side and around 1mm on the left. Mine is out of warranty and it hasn't cracked. I put a couple washers in to bridge the gap and hopefully won't have to bother with it anymore.
