# Kawasaki Ninja 650R / ER-6F (EX650A6F)

## User Guide and Installation Instructions for Cowling Panel Vibration Damper Kit (99999-0093 and 99999-0095)

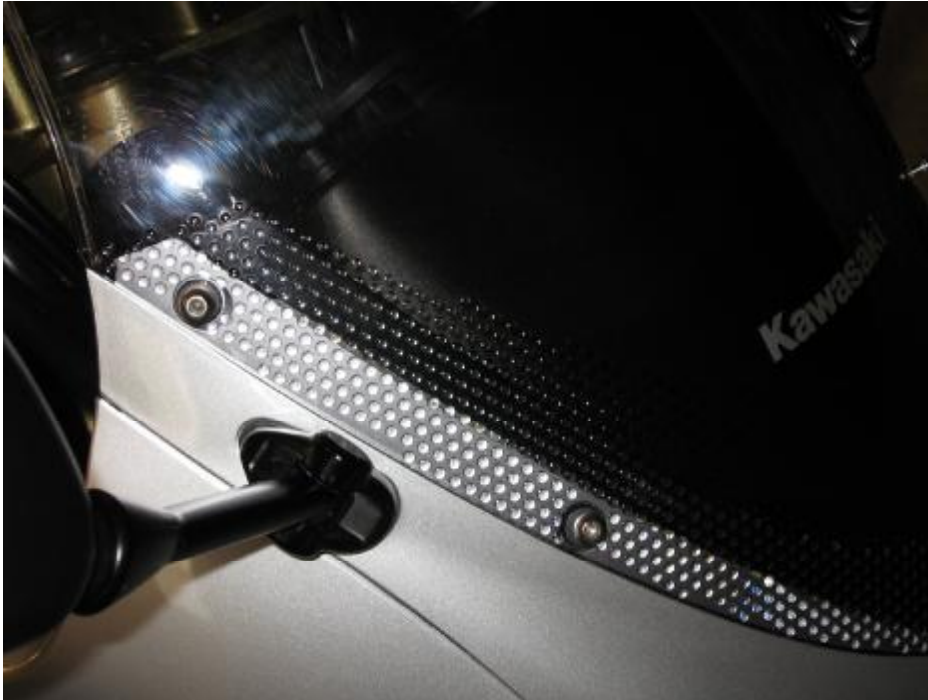
## 1. Windshield

Remove the four hex screws and clear plastic washers that secure the windshield to the upper cowling. Tilt the windshield forward to disengage the tang at the front.

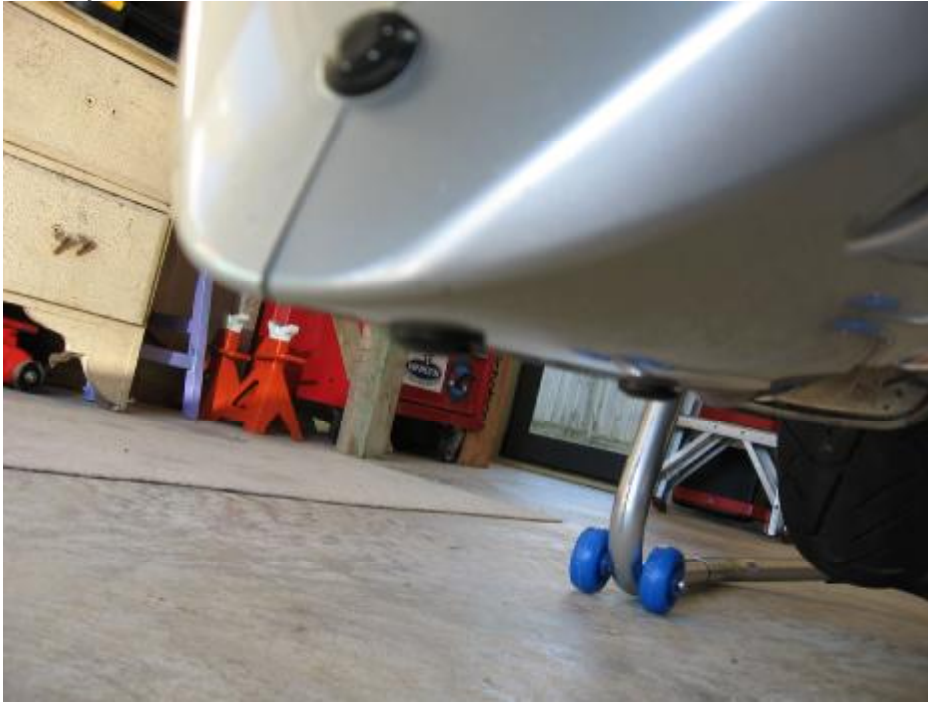
## 2. Belly Pan

Remove the three plastic clips which secure the two halves of the belly pan. First pull the centre pin to it's out position using a flat blade screwdriver, use a spanner or another screwdriver shaft wrapped in a rag to act as a pivot point. Care should be taken not to damage the surrounding paint. With the centre pin pulled out, the clip can be removed by hand.

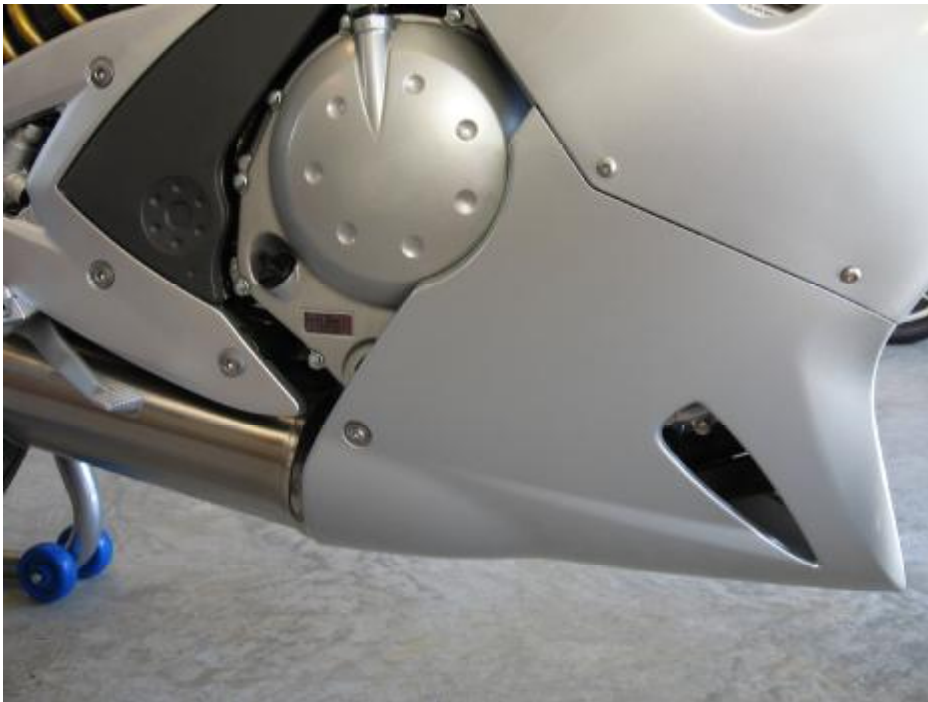
Remove the two hex screws and clear plastic washers on each side that secure belly pan to the left and right main cowling panels. Note these hex screws are longer than all other hex screws used, take care not to mix. Remove the lower rear hex screw, stepped washer and clear plastic washer on each side and remove the belly pan. The left and right main cowling panels have tangs which locate into their respective belly pan halves.

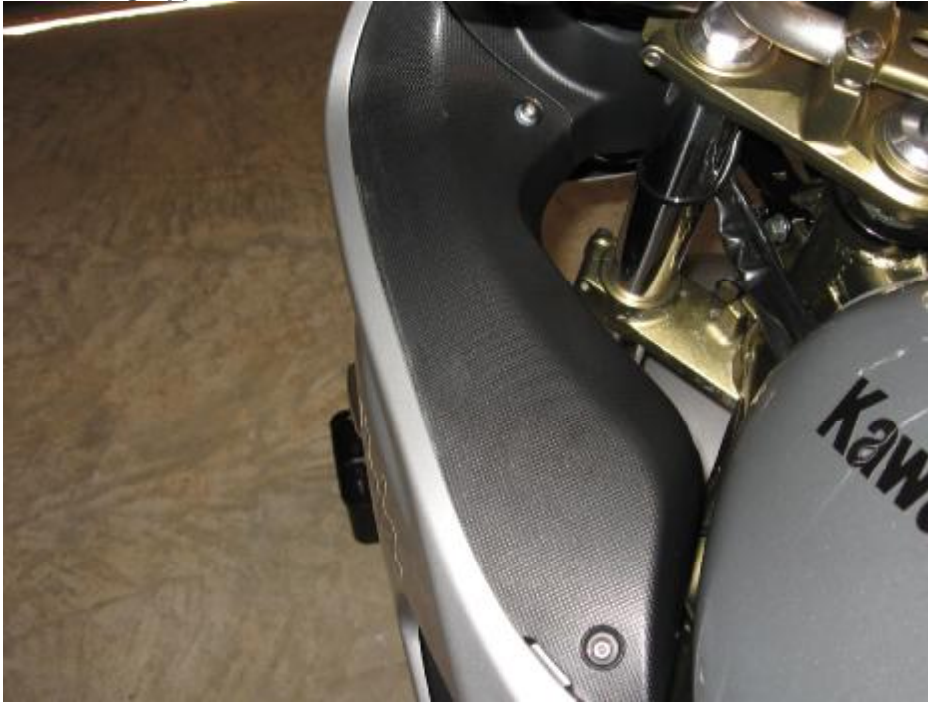
### 3. Cowling Upper Trim Panels

Remove the two hex screws and clear plastic washers on each side that secure the left and right cowling upper trim panels. Note these washers are thicker than all other washers used, take care not to mix. The left and right cowling upper trim panels have a tang which locates into the meter cover.

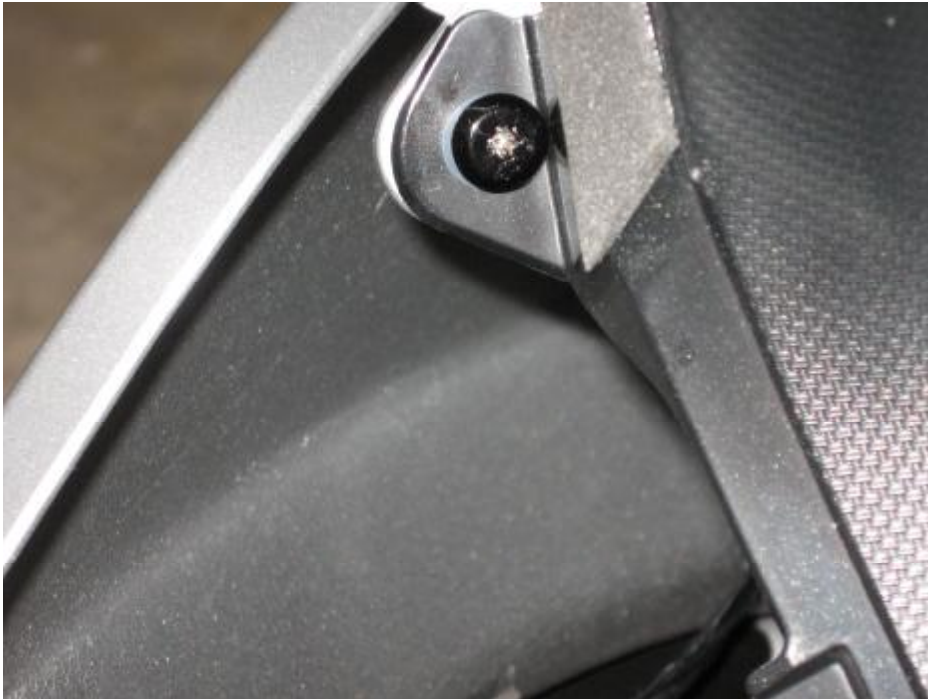
### 4. Meter Cover

Remove the two #1 phillips screws and clear plastic washers on each of the meter; these secure the meter cove to the upper cowling. Pull the meter cover rearward to disengage it from the upper cowling.

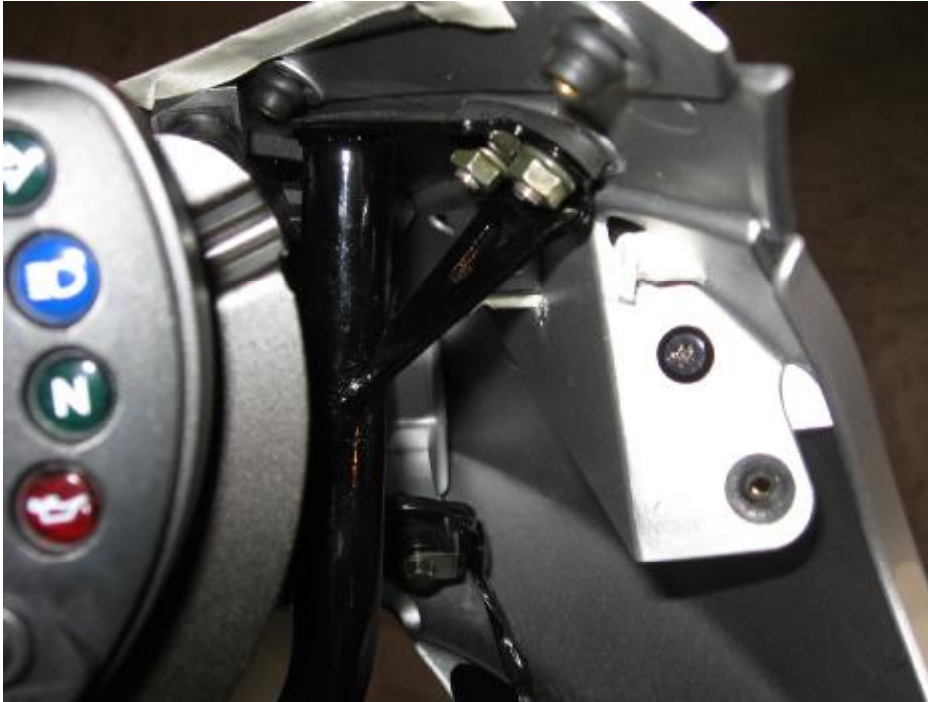
## 5. Rear View Mirrors

Remove the two 10mm nuts on each side that secure the mirror assemblies to the frame. Note there is rubber gaskets each side of the upper cowling. Remove the two #1 phillips screws which connect the centre cowling to the left and right main cowlings.

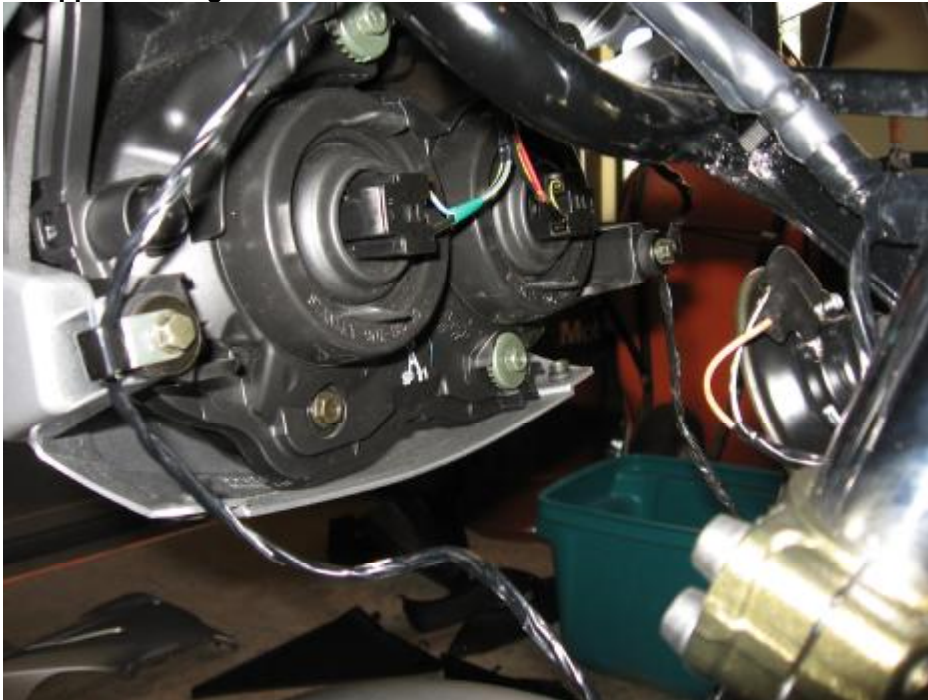
## 6. Upper Cowling

Disconnect the two headlight connectors from the headlight assembly. Open the tabs on each side that secure the wiring to the turn signals.

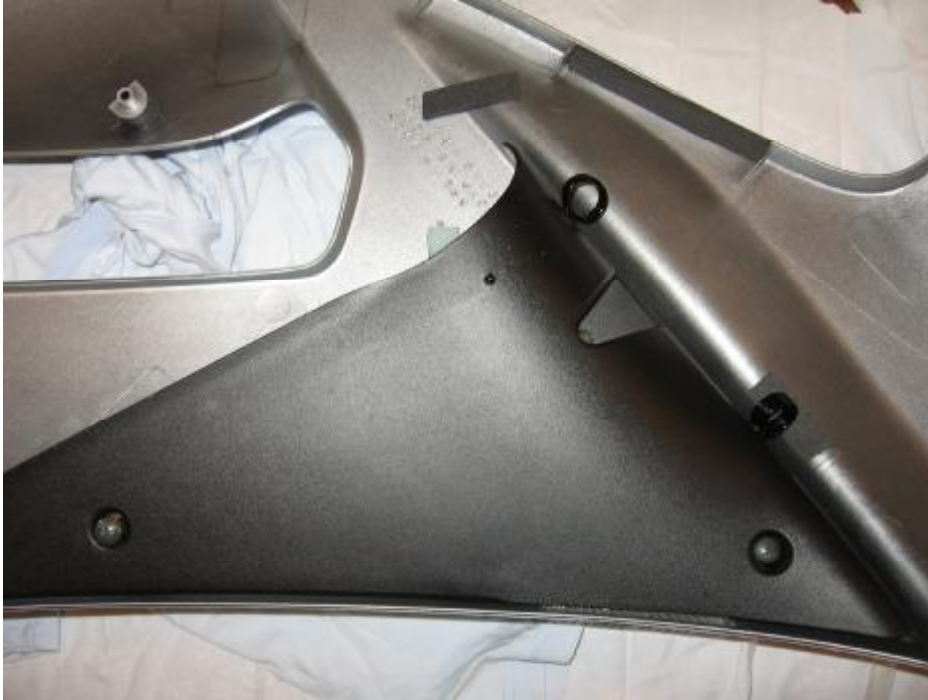
Disconnect the turn signal plugs on each side, these connectors are located under the inner panels between the main cowling and its respective inner panel. Squeeze the locking tang on the side of the connector, and at the same time gently pull the plug halves apart.

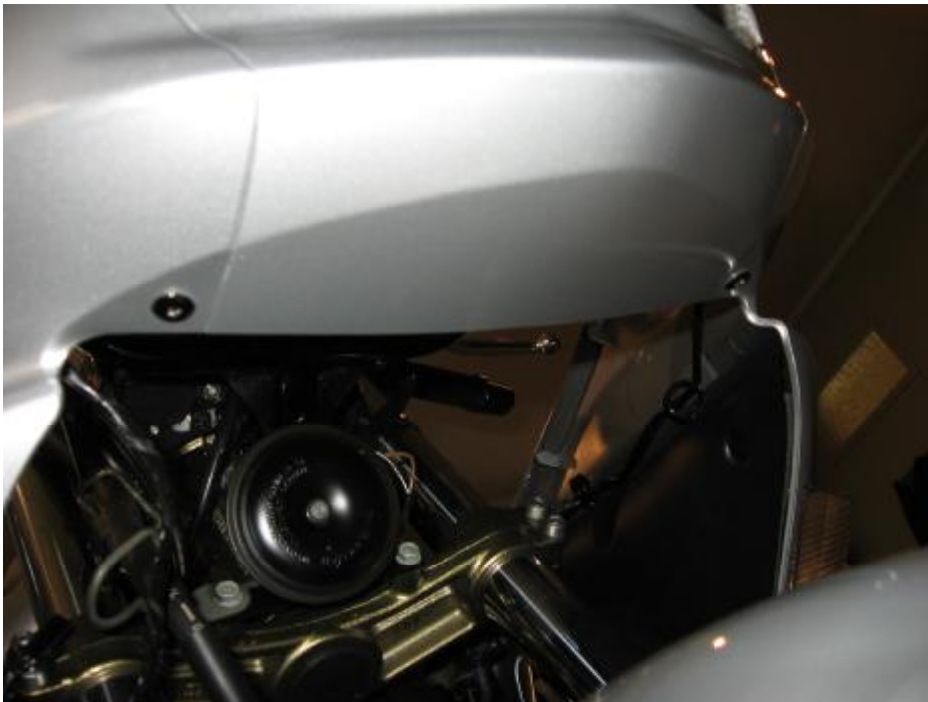
Remove the two #1 phillips screws and clear plastic washers on each of the left and right main cowlings. These are located above the front wheel. Note the upper cowling and headlight assembly is now only secured to the bike by tangs in the left and right main cowlings and the mirror mounting brackets. **Support the upper cowling and headlight assembly until you remove it.**

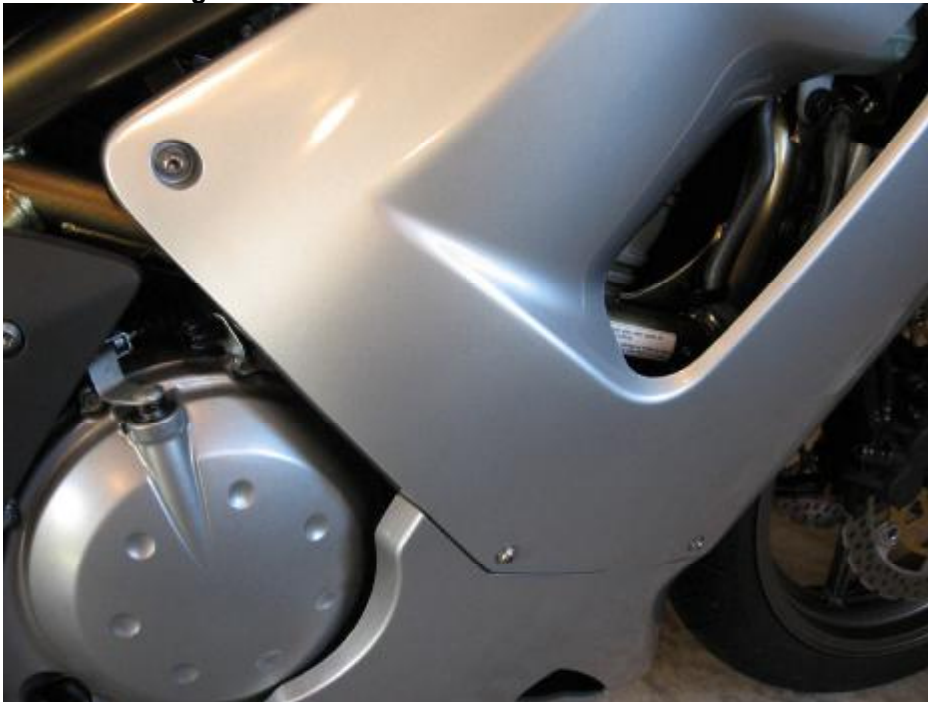
### 7. Main Cowling

Remove the rear hex screw, stepped washer and clear plastic washer on each side and remove the left and right main cowling panel. The left and right main cowling panels have a pin which pushes through a rubber grommet in the frame.

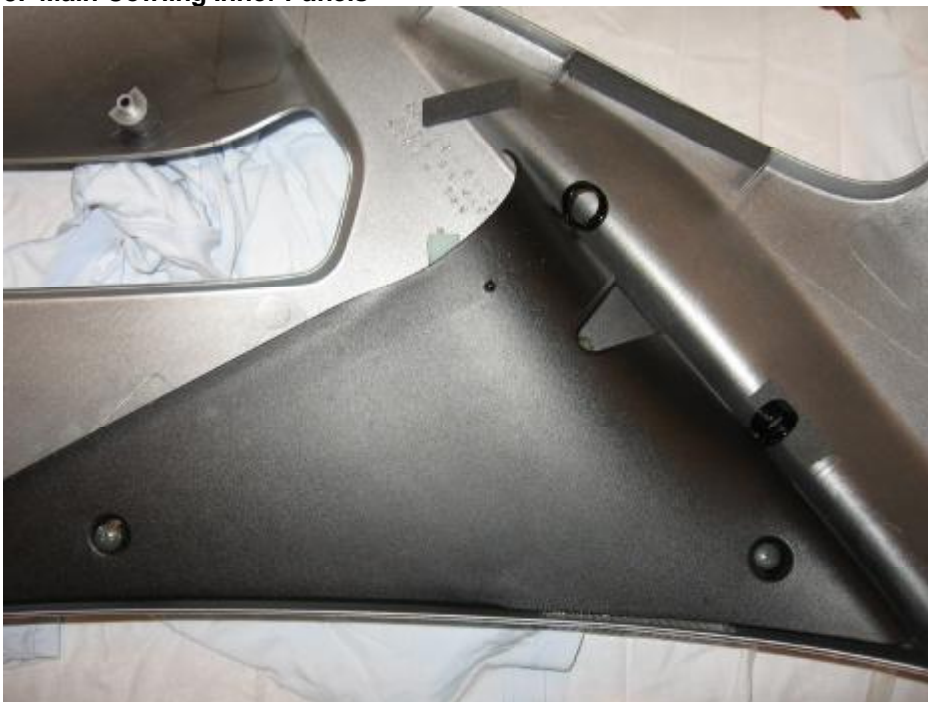
### 8. Main Cowling Inner Panels

Remove the three #2 Phillips head self tapping screws on each side of the left and right main cowling panel.

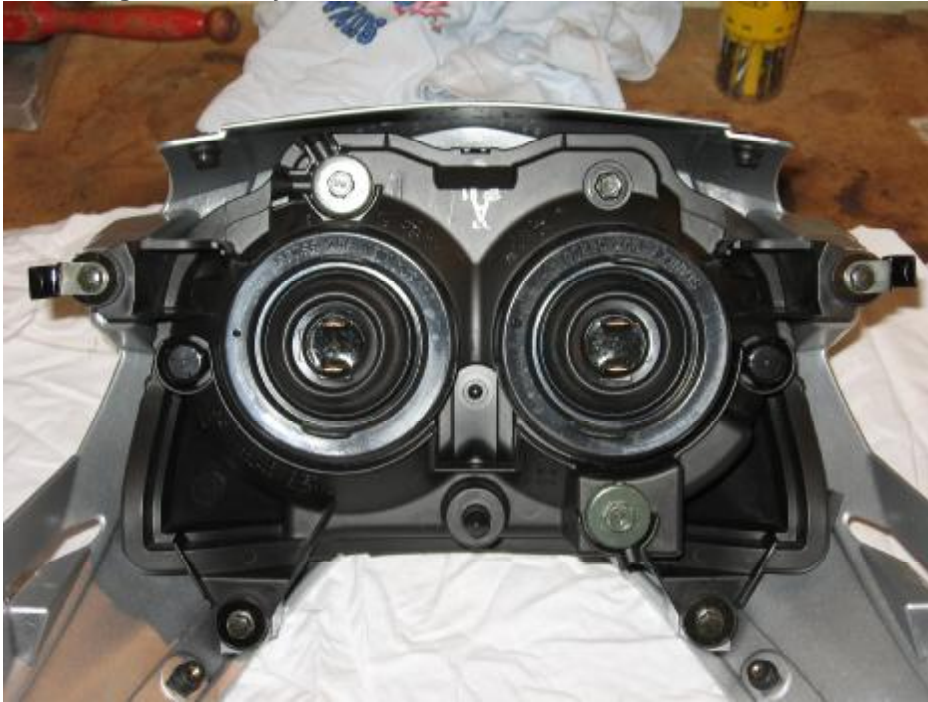
## 9. Headlight Assembly

Remove the four 8 mm bolts that secure the headlight assembly to the upper cowling. Note: Do not touch any other bolt, these are used for headlight adjustment.

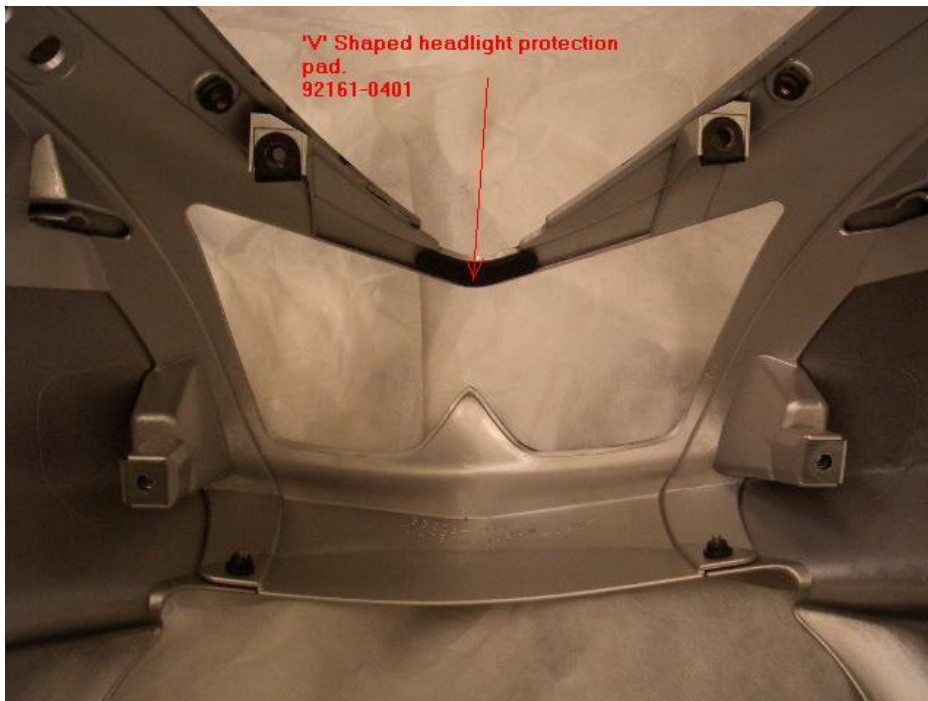
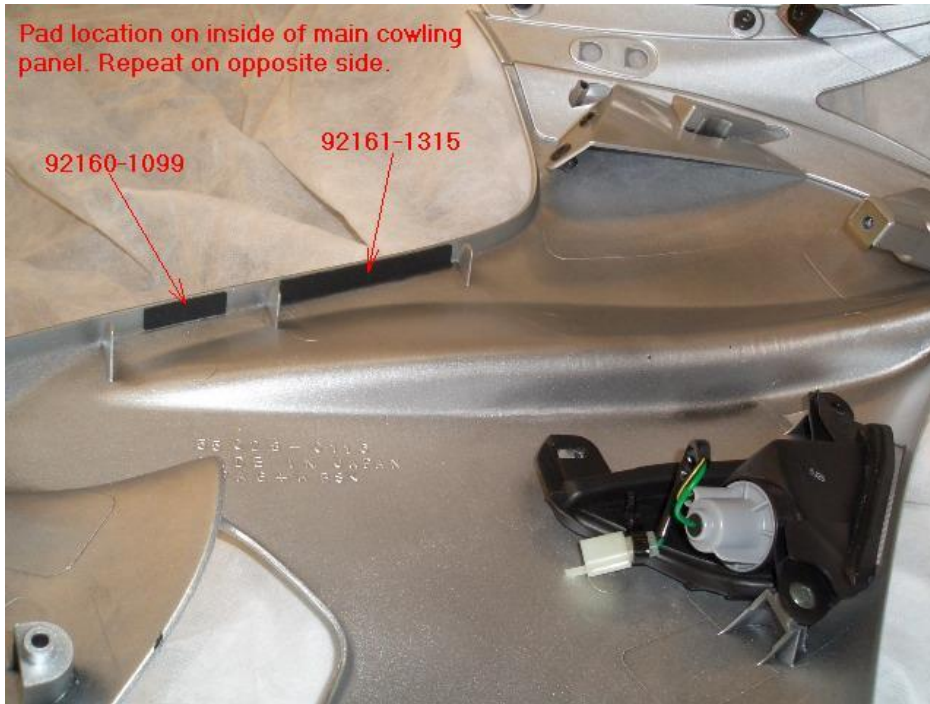
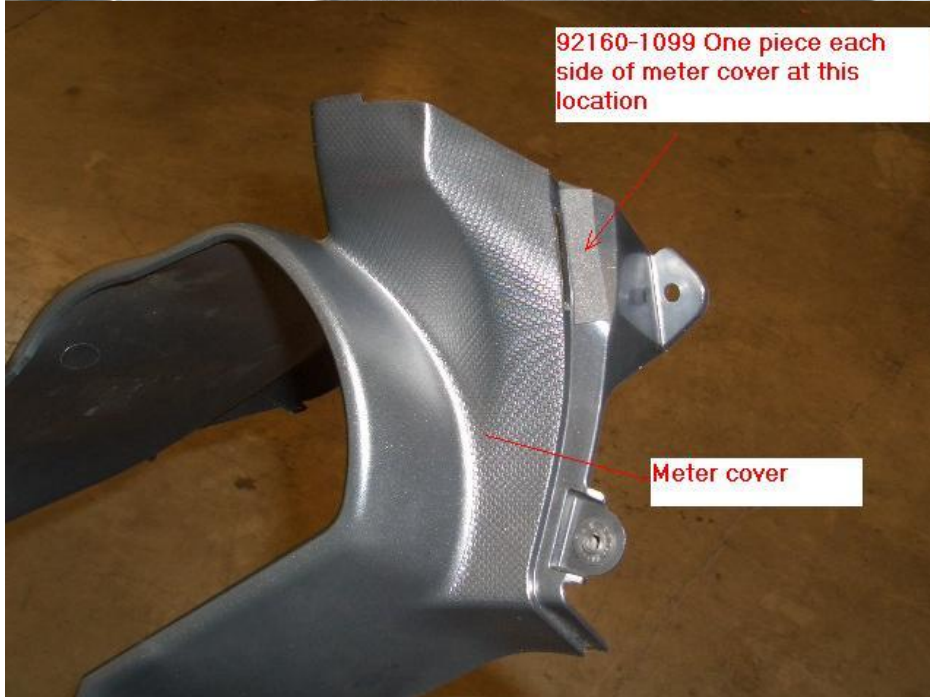
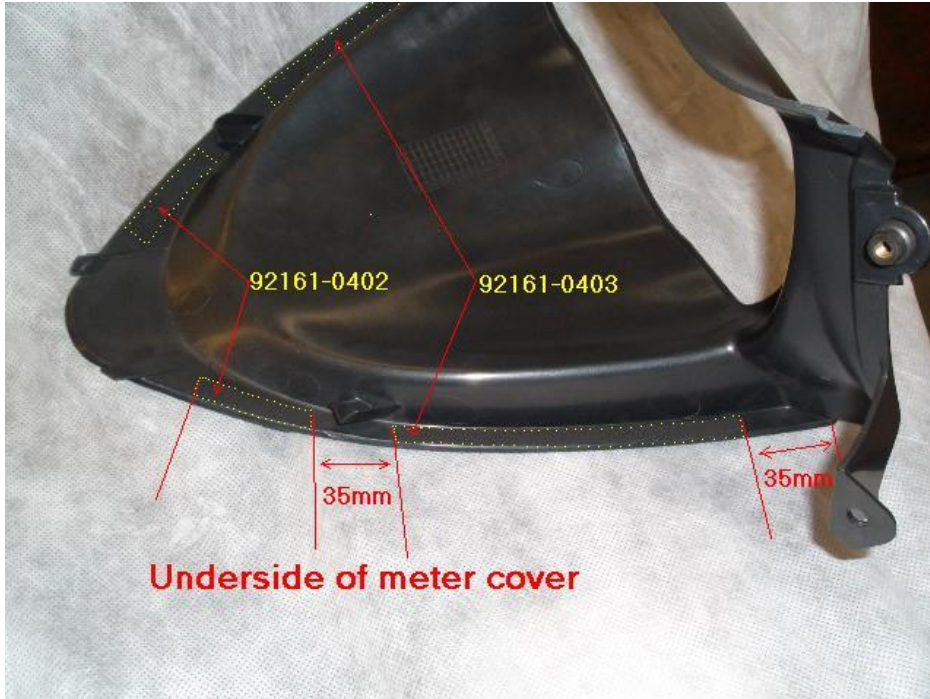
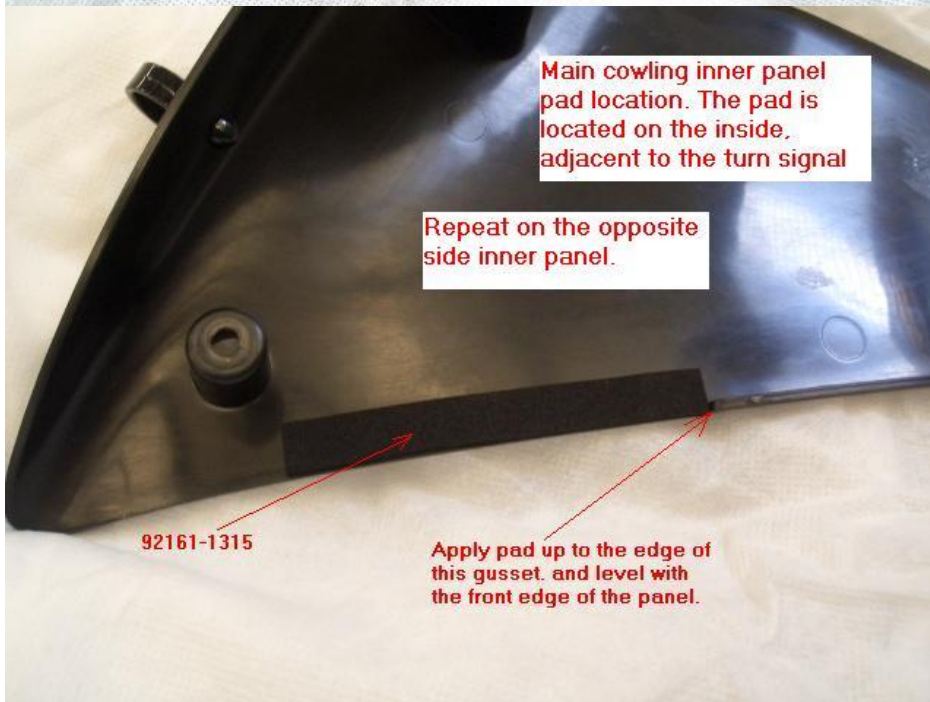
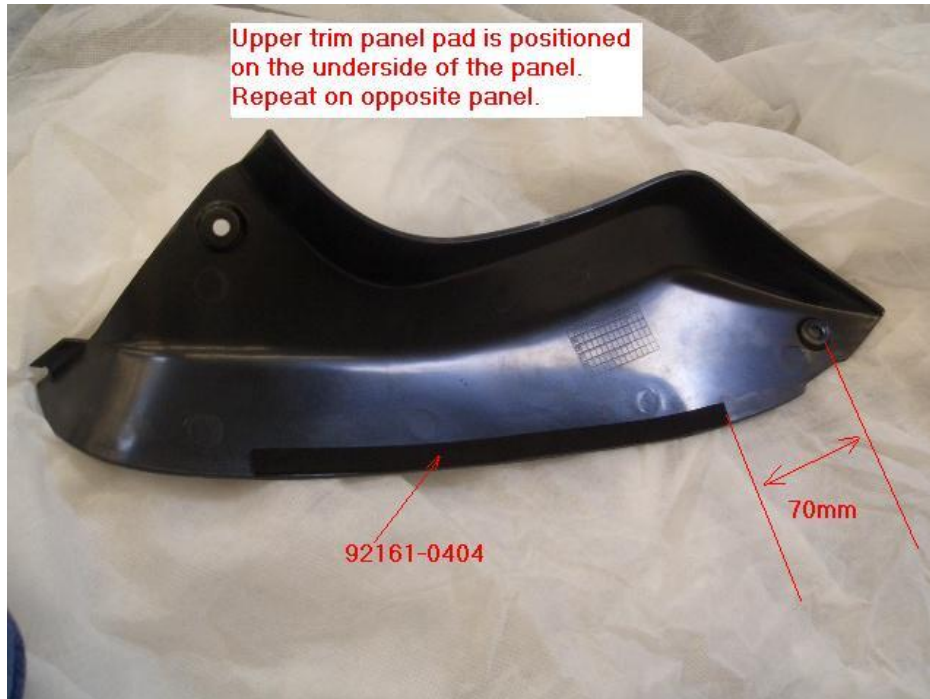
## 10. Modification

Using the following photos as a guideline, install the foam dampers in the positions indicated:

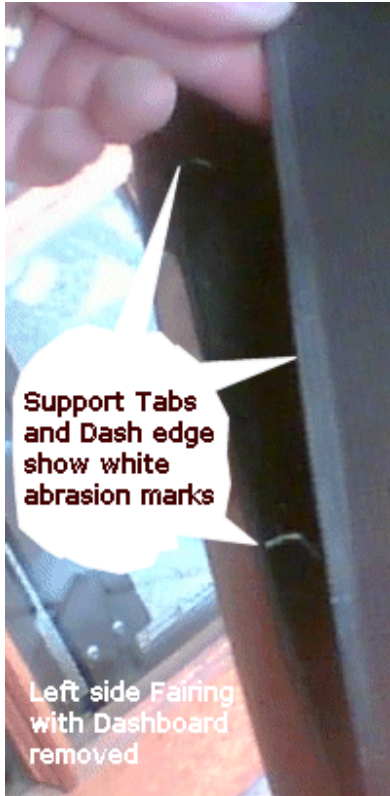
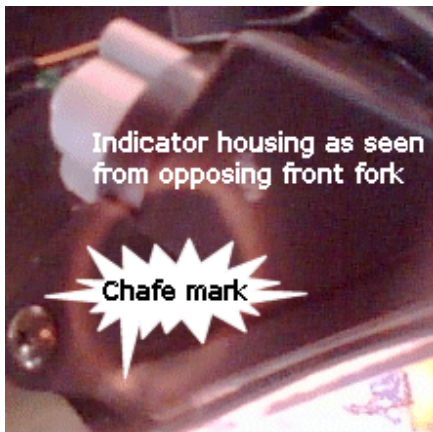
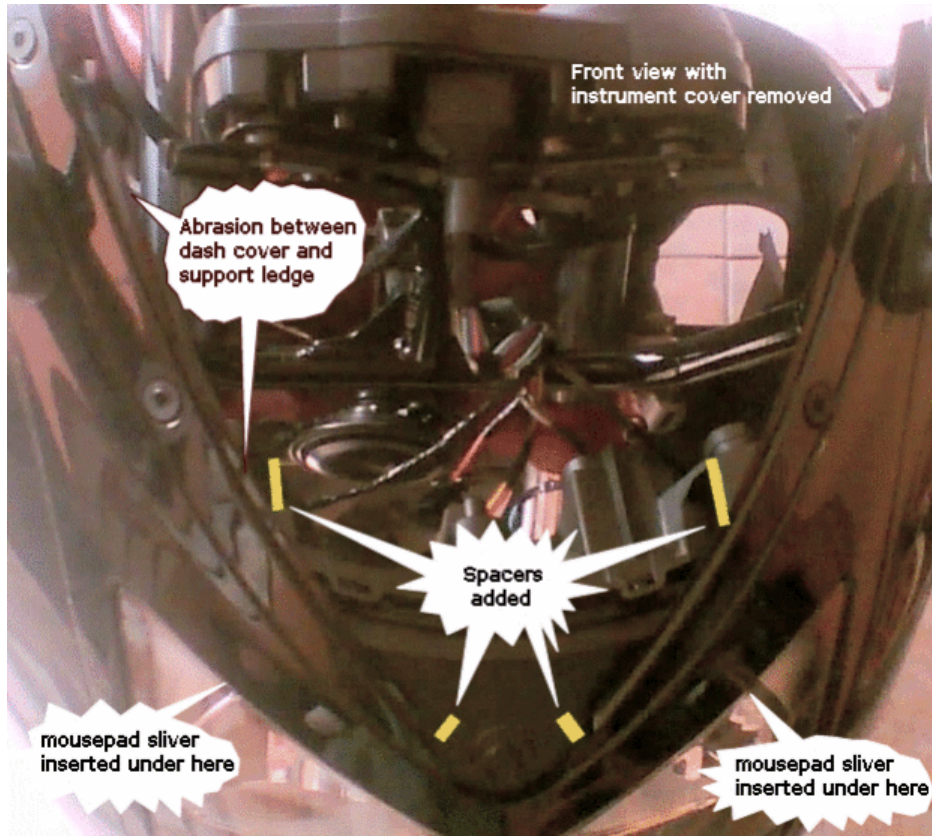
1. The "horizontal dash" pieces have three vertical support tabs underneath that buzz and rattle (mainly around the 2K / 4K frequency.) I could see chafe marks on the underside of the dash and abrasion patches on top where it meets the underside of the fairing lip. Added pieces over the tabs only . . . presses up against the outside fairing now.

2. The vertical "side cover" inside the fairing (part 14091-0596) was making contact with a 1/4" slightly raised section just before the bottom corner of the indicator housing / bracket. Added a strip there. When the cover is replaced, the mouse pad-sliver starts where the cover lip ends to make space for the indicator housing anyway. (There is also some rattle buzz inside the flicker unit I didn't solve)

3. The fairing "nose" which goes all around the headlights had the loudest, angry buzz at the 4K mark. This segment is actually quite loose-fitting in that you can see background light almost all the way around. The nose of the gray V-shaped instrument "dash-cover" (part 55028-0081) has two small tabs that slot under the fairing ridge to hold it down. In addition, the windscreen nose slots in there as well. When you hold the screen as some have reported, this action often lifts the screen and instrument cover off the headlight assembly, solving the buzz. I decided to simply keep it all lifted up, inserting two 3-inch long sections under the fairing nose plastic that encircles the headlight - roughly above each of the headlight bulbs.

There were three other vibration patches visible between the "instrument dash" and the fairing it rested on (pics will help, I know ). There was also a Z-shaped tab on the underside of this dash that did NOT make contact with anything - so I really don't know what it was for. It nestles close to the top of the headlight assembly, so I added some tape there to prevent any left-right movement. This made a very snug fit, which was further enhanced by two strips towards the top of the V, where it rested on the fairing tray. (yes, it bulged up slightly, but is hard to see, especially with the screen attached.)

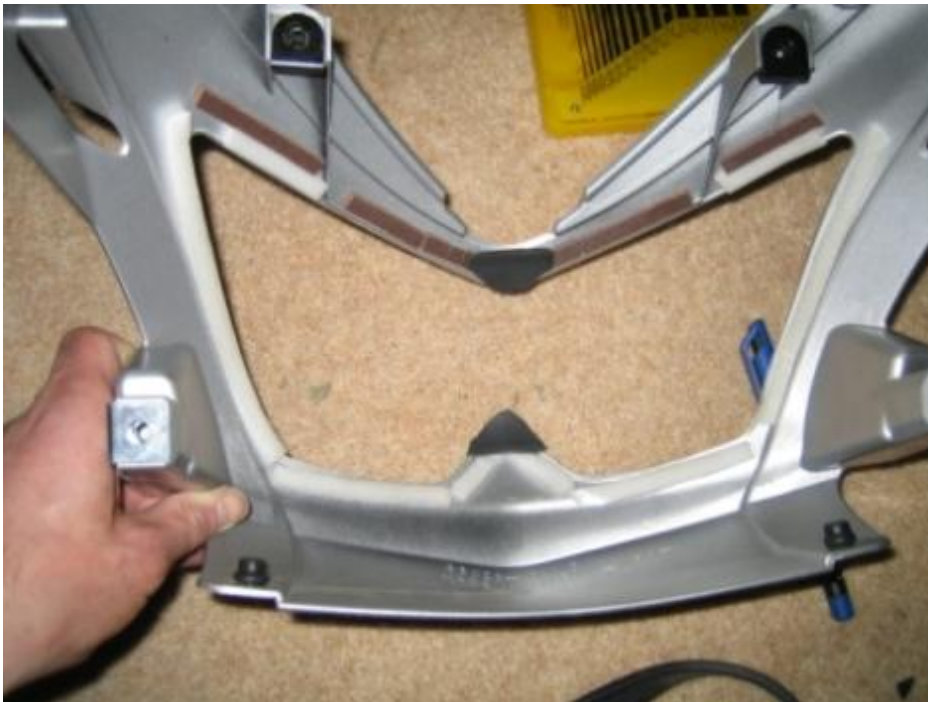
After some experimentation, I found that the upper cowling directly underneath the headlight seemed to be making the noise. It seemed that the insulation I'd done there was not good enough.

I took some soft rubber strip a few millimetres wide (dunno what it is used for - found it in the hardware store; neoprene would work well too, as this was quite similar to neoprene in terms of weight and compressibility) and using double sided tape, stuck it to the bottom part of the upper cowling assembly just below the headlight. For good measure, I added some to the top part too, as indicated in the picture below.

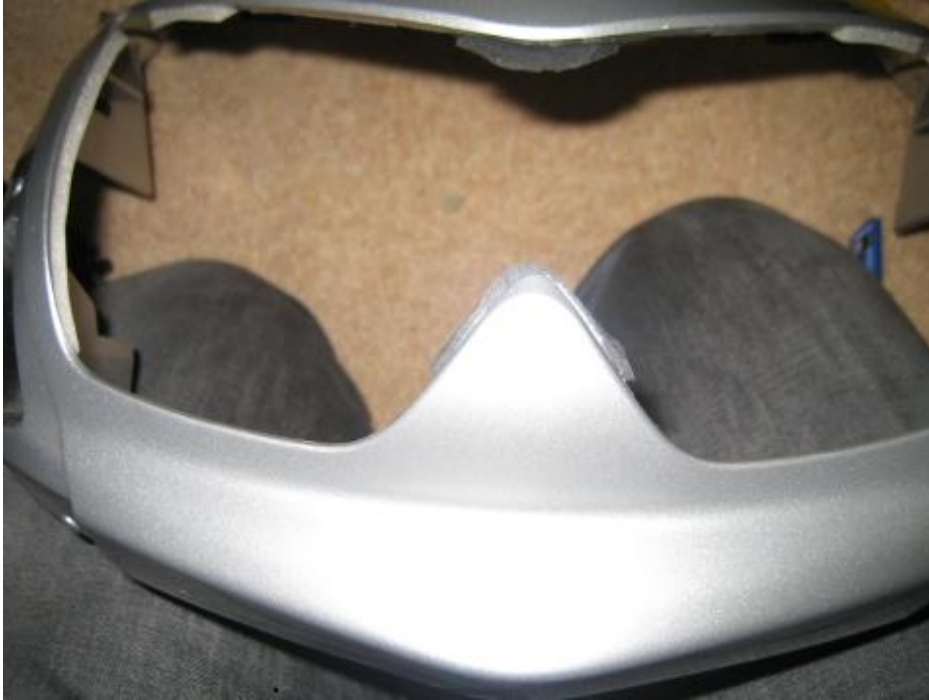
The key to eliminating the buzz in my case was to ensure that the rubber that I put onto the cowling just below the headlight protruded a couple of millimetres so that when the headlight was put back in place and mounted using the bolts, it sandwiched the rubber between the headlight and the cowling. The following picture shows the rubber protruding enough to create a reasonable damping effect:

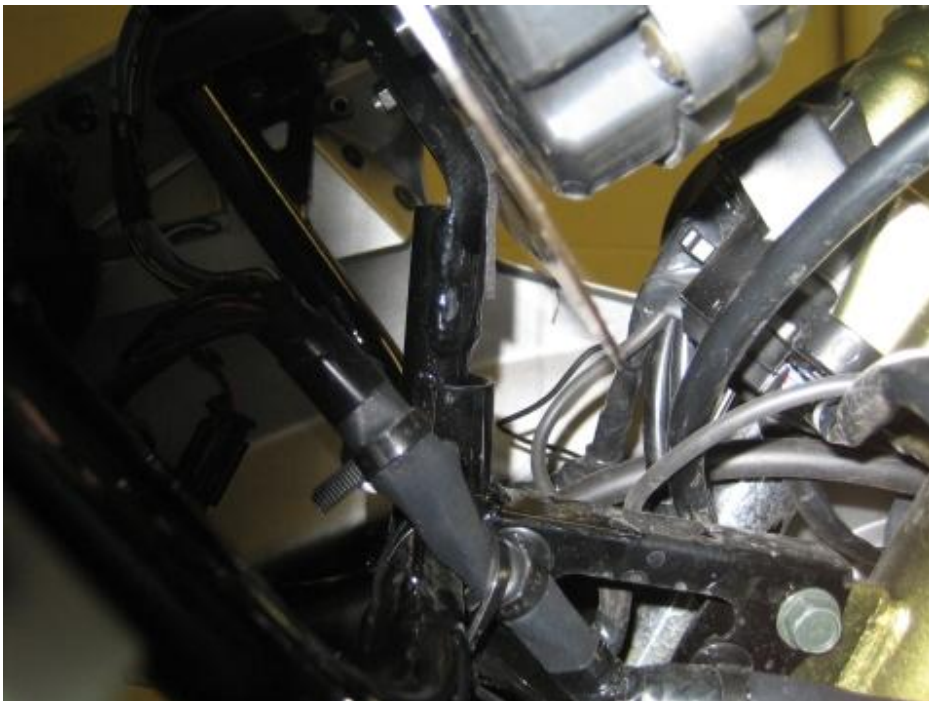
As Shane pointed out earlier, the cabling for the instruments and lights runs quite close to the meter cover. I cable tied it so that there was no chance of it touching the meter cover. There's a hole in the mounting assembly just below the cable that you can use to pass a cable tie through. In the pic below, the cable tie I added is in the bottom middle of the image:
