INFORMATION TECHNICAL IT1005

Model: ER650A6S

Subject: Route of the electrical system – CAMPAIGN

Asunto
Ruta de la instalación eléctrica –CAMPAÑA-

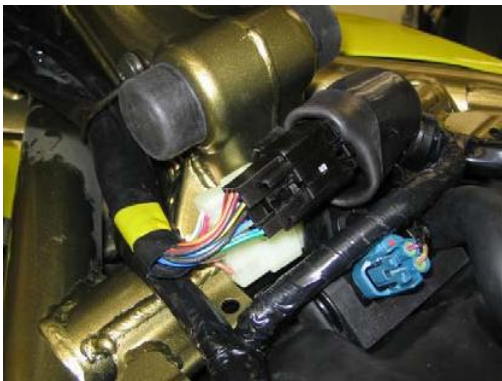
En ciertas unidades, la ruta del mazo de cables puede producir que el conector situado bajo el depósito de combustible entre en contacto con el soporte del bastidor. Bajo un uso continuo de la motocicleta, el mazo de cables puede resultar dañado o cortado causando un cortocircuito y un fallo instantáneo en el circuito de encendido, creando una situación de peligro para el conductor.

Antes de la reparación:
El conector del encendido (blanco) está debajo, y el conector del interruptor izquierdo del manillar (negro) encima.

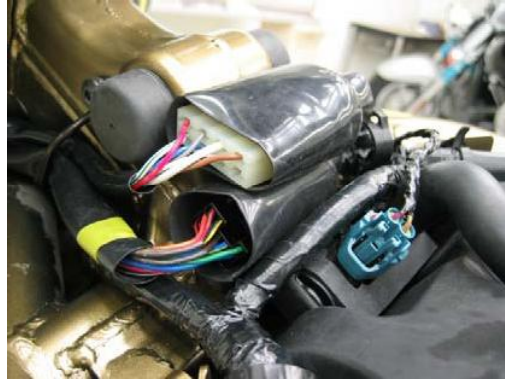
Después de la reparación:
El conector del encendido (blanco) está encima, y el conector del interruptor izquierdo del manillar (negro) debajo.
