Fractures Reported on Kawasaki ER6 Frames

Kawasaki Facing Pressure over ER-6 Frames

Kawasaki Replaces MCN Reader's Cracked ER-6 Frame

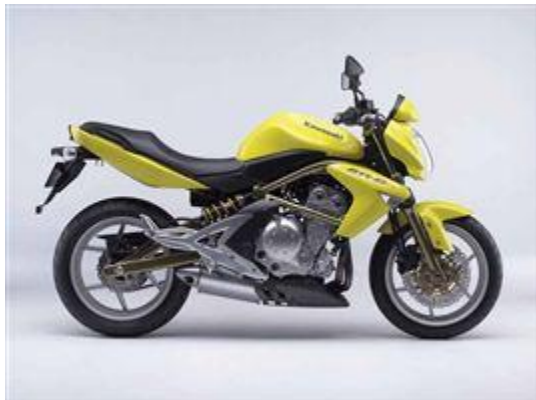
Fractures have been reported on the frames of Kawasaki ER6s

The problem lies with the engine mount on the right hand side (at the front of the tube that wraps around the cylinder), where a weld can split on the underside of the tube. The problem can be difficult to spot (ER6-F models will require the right hand side fairing to be removed), but tell tale signs include paint flaking off and rust forming on the bare metal.

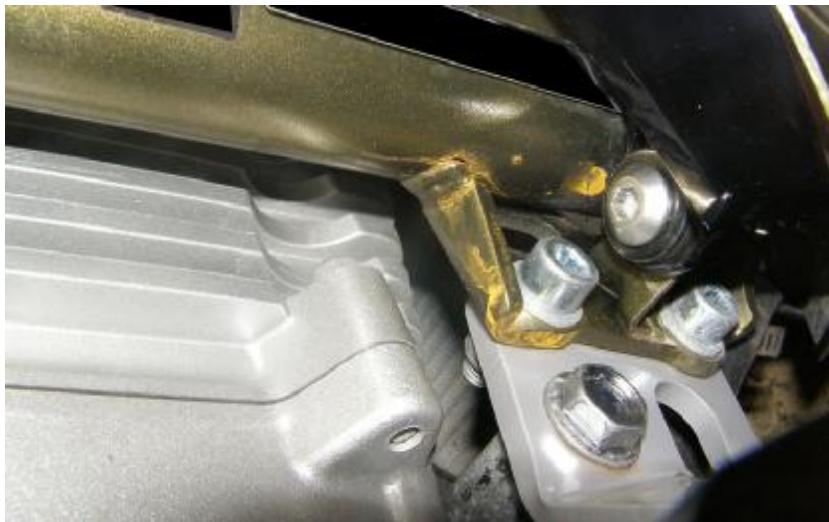
Cracks have appeared on an MCN reader's ER-6

The apparent problem lies with the engine mounting bracket on the right hand side – on 2006 model Kawasaki ER-6n and ER-6f machines owners across the globe have reported splitting welds.

Owners on specialist ER-6 websites have attributed the problem to incorrect frame/engine spacing, allowing the bracket to bend when the engine mounting bolt is torqued down.

"My view is that when you tighten the engine bolt it twists the bracket which snaps under stress. When you undo the bolt, the bracket springs open and opens a gap. The spacer is about 6mm too short. And to fit crash bungs you don't have to undo the main engine mounting bolt."

Kawasaki dealers have been sent a 'Technical Service' bulletin relating to the issue. It says the problem could be caused by bungs concentrating vibrations in the brackets – but also says that an early design of genuine Kawasaki crash protectors can also cause the problem.

The document instructs dealers to remove old design mushrooms and replace them with revised bungs – and to remind customers with aftermarket protectors that any problems relating to their fitting would not be covered under warranty.
